Gate Drive Optocoupler Provides Robust Insulation in IGBT Destructive Tests

White Paper

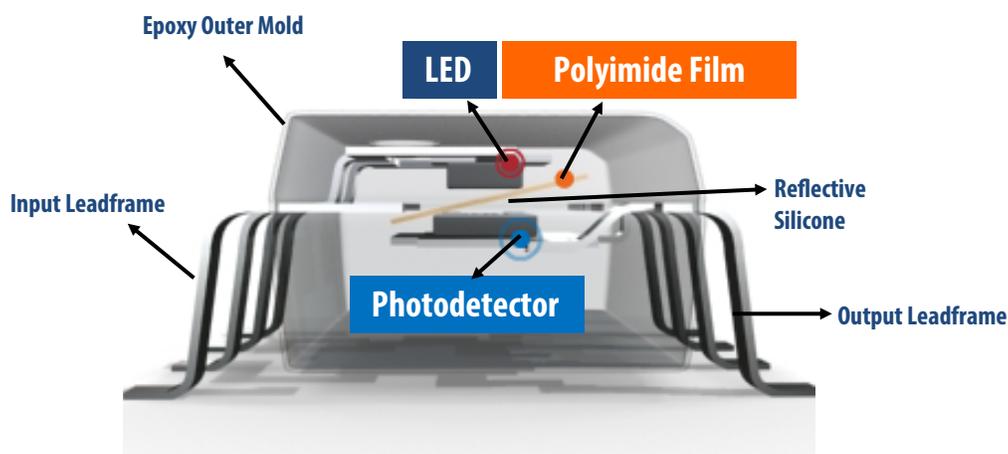
Optocoupler's Structure with Three Layers of Insulation Barrier

Avago Technologies optocouplers provide reinforced insulation by wide Distance Through Insulation (DTI) between the LED and detector and three layers of insulation barriers. The three layers of insulation are made up of silicone, polyimide film, and silicone. Polyimide film is developed specifically to withstand the damaging effects of partial discharge, which can cause ionization and breakdown of insulation material. Polyimide's unique properties of high dielectric strength and a wide temperature range allow it to be used extensively for a range of electrical insulation applications, from locomotives to aerospace. The polyimide film used in Avago Technologies optocouplers has a typical dielectric strength of 300 kV/mm and can withstand temperatures as low as -200 °C and as high as 400 °C.

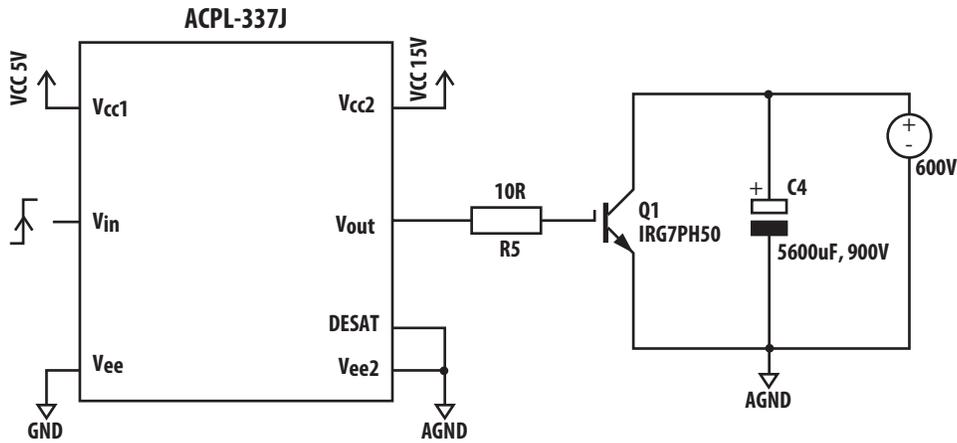
Figure 1 IGBT Short Circuit Test Setup

The ACPL-337J was used to drive the gate of a 1200-V/150-A IGBT. The ACPL-337J provided galvanic isolation between the high voltage and logic power supply and was supplied by a unipolar 15-V supply. The IGBT was connected to 5600- μ F DC-link capacitor at a bus voltage of 600 V to create high current short circuit when turned on. The DESAT pin of ACPL-337J was grounded to disable the DESAT protection feature and prevent automatic shut down of the IGBT during short circuit. The clamping diode was not used to mitigate the impact of the destructive energy to the gate driver.

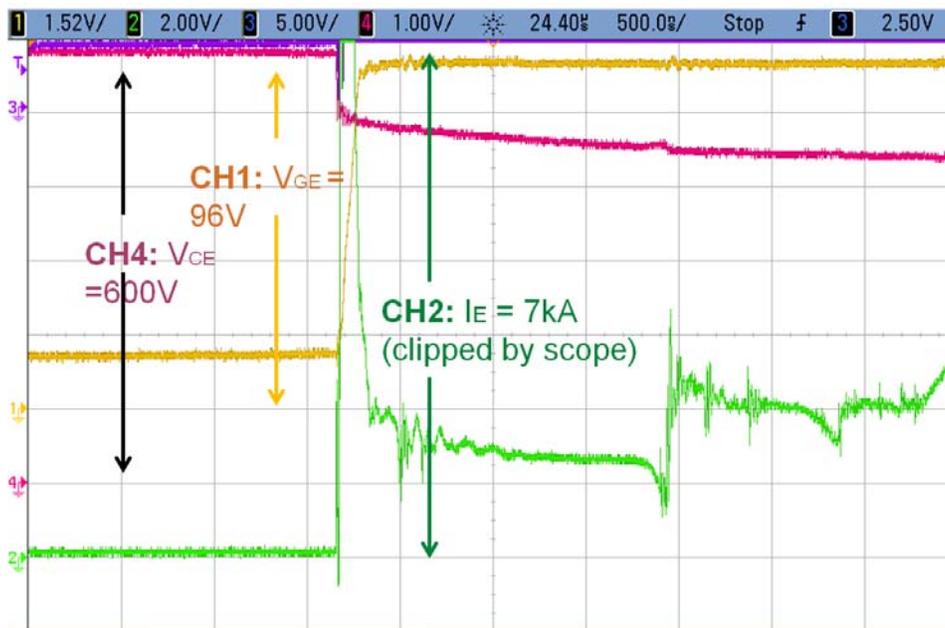
Figure 2 IGBT Short Circuit Waveforms

When short circuit occurred, the IGBT was driven into shoot through and an emitter current, I_E of 7 kA was recorded as shown Figure 2. The IGBT did not saturate (V_{CE}) and the gate emitter voltage (V_{GE}) increased tremendously, driving itself into thermal overload. This voltage was fed back to the ACPL-337J under test.

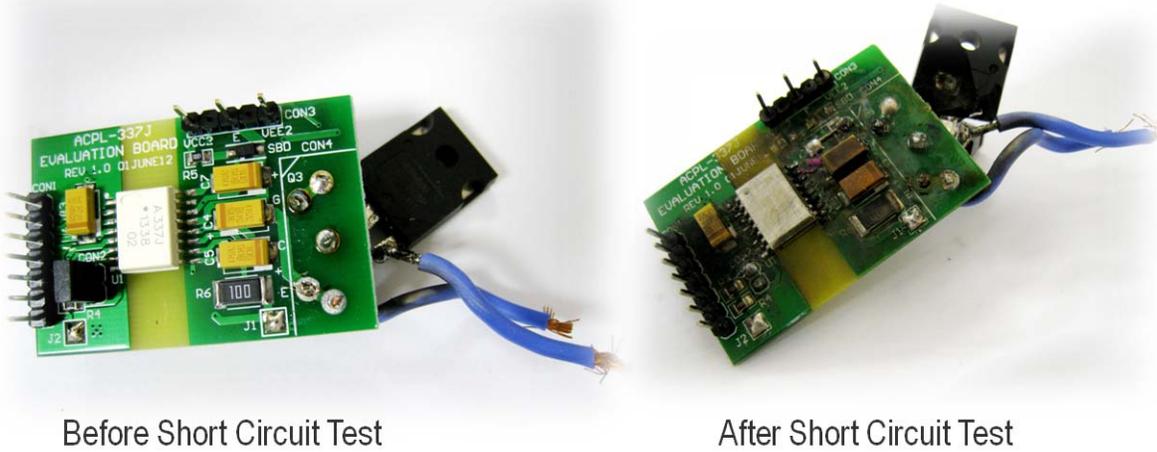
Figure 3 The ACPL-337J Gate Driver Board Before and After Short Circuit Test

The case of the ACPL-337J remained intact except from the burns of the IGBT blast. Many discrete components were damaged, and the gate driver board was not functional.

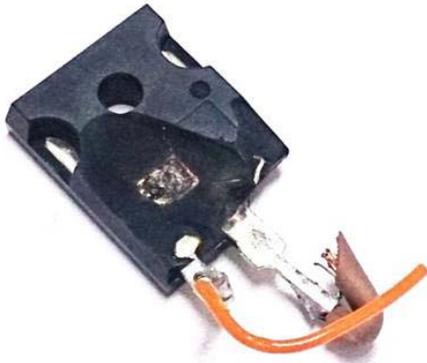
Figure 4 The Destruction of the IGBT After Short Circuit Test

The ACPL-337J was electrically tested, and it passed the rated partial discharge test (1.88 kV_{RMS}/s) and high voltage insulation test (6.2 kV_{RMS}/s). Visual inspection was done externally and internally to determine the degree of damage to the insulation barrier.

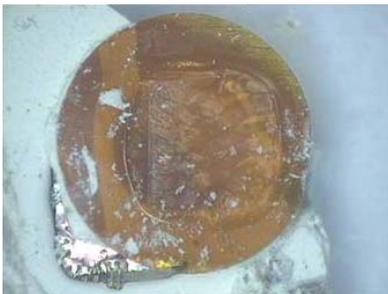
Figure 5 The Polyimide Film of the ACPL-337J After Short Circuit Test

Optical inspection of the polyimide film showed no damage and the insulation remained intact.

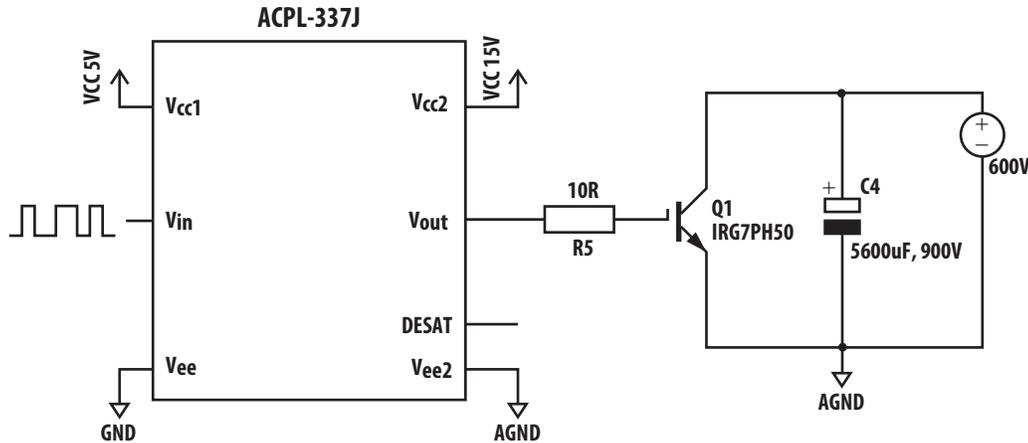
Figure 6 Repeated IGBT Short Circuit Test Setup

The test setup was the same as the short circuit test, except the DESAT pin of ACPL-337J was left floating. The ACPL-337J will shut down the IGBT at every short circuit cycle after a blanking time of about $1 \mu\text{s}$. It would require about 10 to 20 pulses with variable period of about 2 s to cause repeated high IGBT V_{CE} overshoot and burn the IGBT. The ACPL-337J was electrically tested, and it passed the rated partial discharge test ($1.88 \text{ kV}_{\text{RMS}}/\text{s}$) and high voltage insulation test ($6.2 \text{ kV}_{\text{RMS}}/\text{s}$).

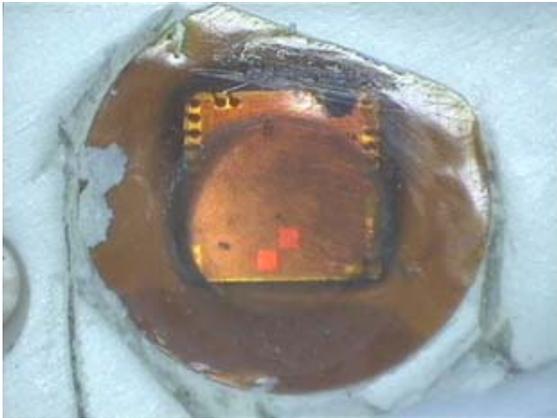
Figure 7 The Polyimide Film of the ACPL-337J After Repeated Short Circuit Test

The gate driver board was not functional, but optical inspection showed no damage to the polyimide film and the insulation remained intact.

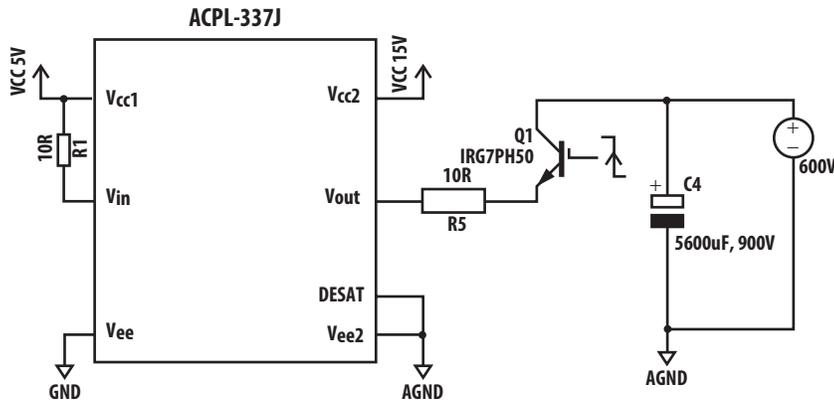
Figure 8 Direct Current Injection Test Setup

In this test, the IGBT was used to inject high current into the output of the ACPL-337J. The IGBT was triggered with a single 15-V pulse and the gate driver's input was kept at high logic. The IGBT was connected to a 5600- μ F DC-link capacitor at a bus voltage of 600 V.

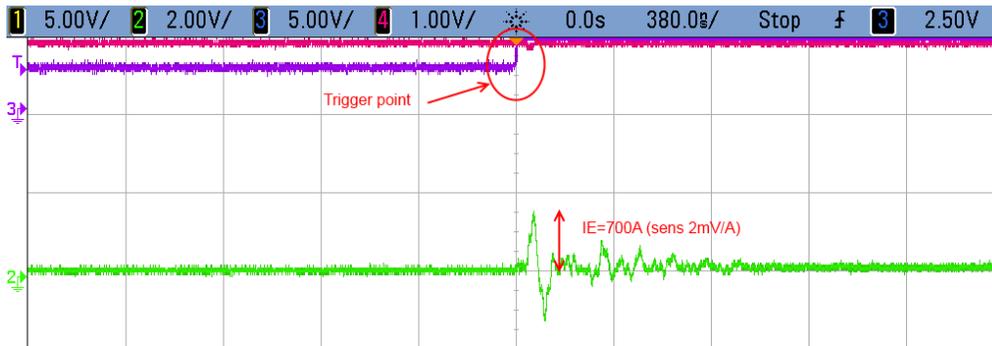
Figure 9 Direct Current Injection Waveforms

When 15 V was triggered at the gate of the IGBT, approximately 700-A emitter current was registered on the scope. This was the worst destructive test as direct energy flowed into the gate driver, causing severe damage to the gate driver board.

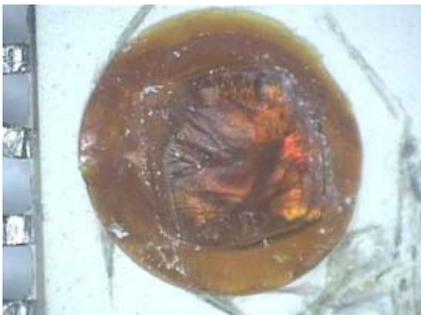
Figure 10 The Polyimide Film of the ACPL-337J After Direct Current Injection Test

The ACPL-337J was electrically tested and passed the rated partial discharge test (1.88 kV_{RMS}/s) and high voltage insulation test (6.2 kV_{RMS}/s). There was no damage to the polyimide film and the insulation remained intact.
